## **SR 22 YAKIMA RIVER CED RETROFIT**

### **MARCH 11, 2005**

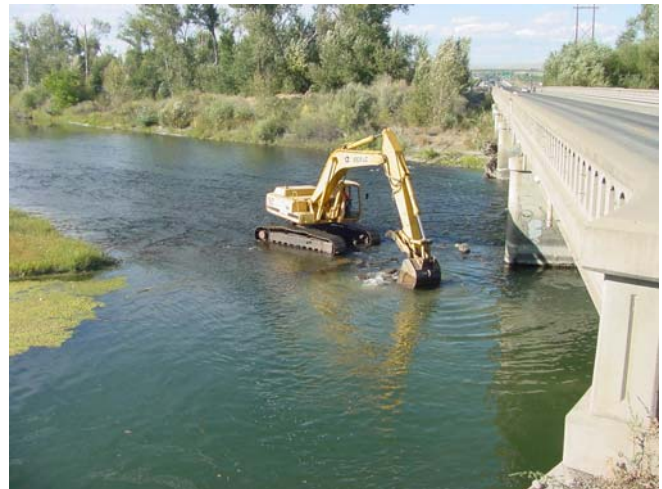
Figure 1. Maintenance workers fill in a scour hole to protect a bridge pier at the SR 22 Yakima River Bridge.

The three bridges that exist within the Yakima River floodplain were built using a previously approved design using shallow spread footings that support the bridge structures. This design is susceptible to scour and undercutting by the river. Bridge scour and bank erosion problems at this location have necessitated repetitive channel stabilization measures that have resulted in impacts to fish habitat.
